MODEL 11.206 /216 /223 /226 /242 /243 /256 /261 /265 /270 1#
Vehicles as of model year 2003 (code 803) with Audio 20 CD radio

A2/56 Radio control panel and navigation unit

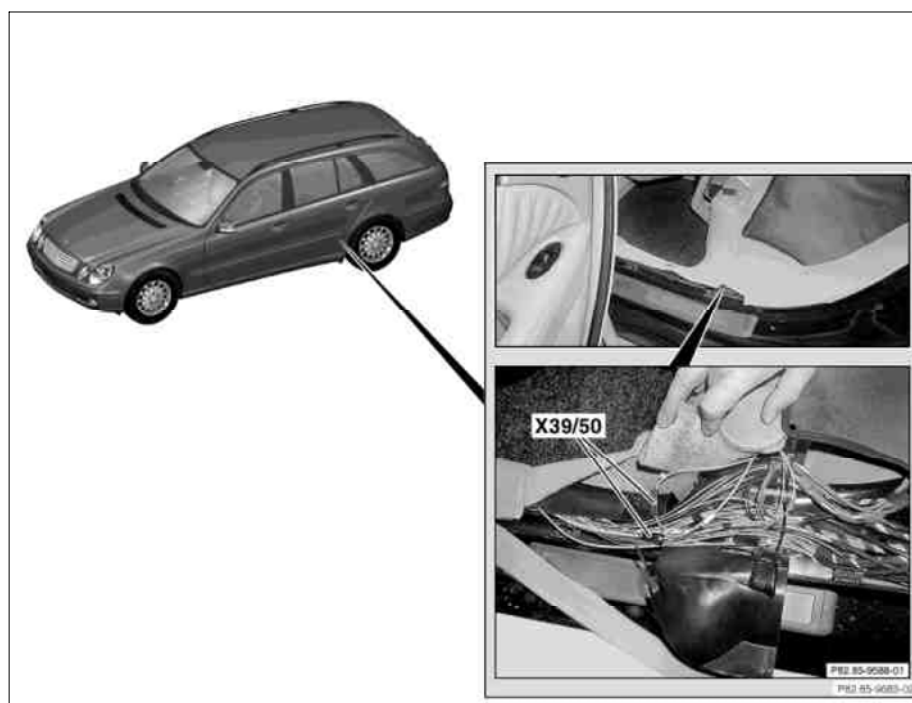
P82.61-2854-06

i The fiber optic cable connector (MOST) (X39/50) is located in the rear cable duct, to the left of the rear bench seat. It always has to be checked, whether it exists, since there are also vehicles with several or no fiber optic cable connectors (MOST).
